# **BIG QUOKKA PTY LTD**

## **TEST REPORT**

AS 1530.8.1:2018+A1:2024 TESTING ON PREMIUM PVC DECKING

250108015SHF-001

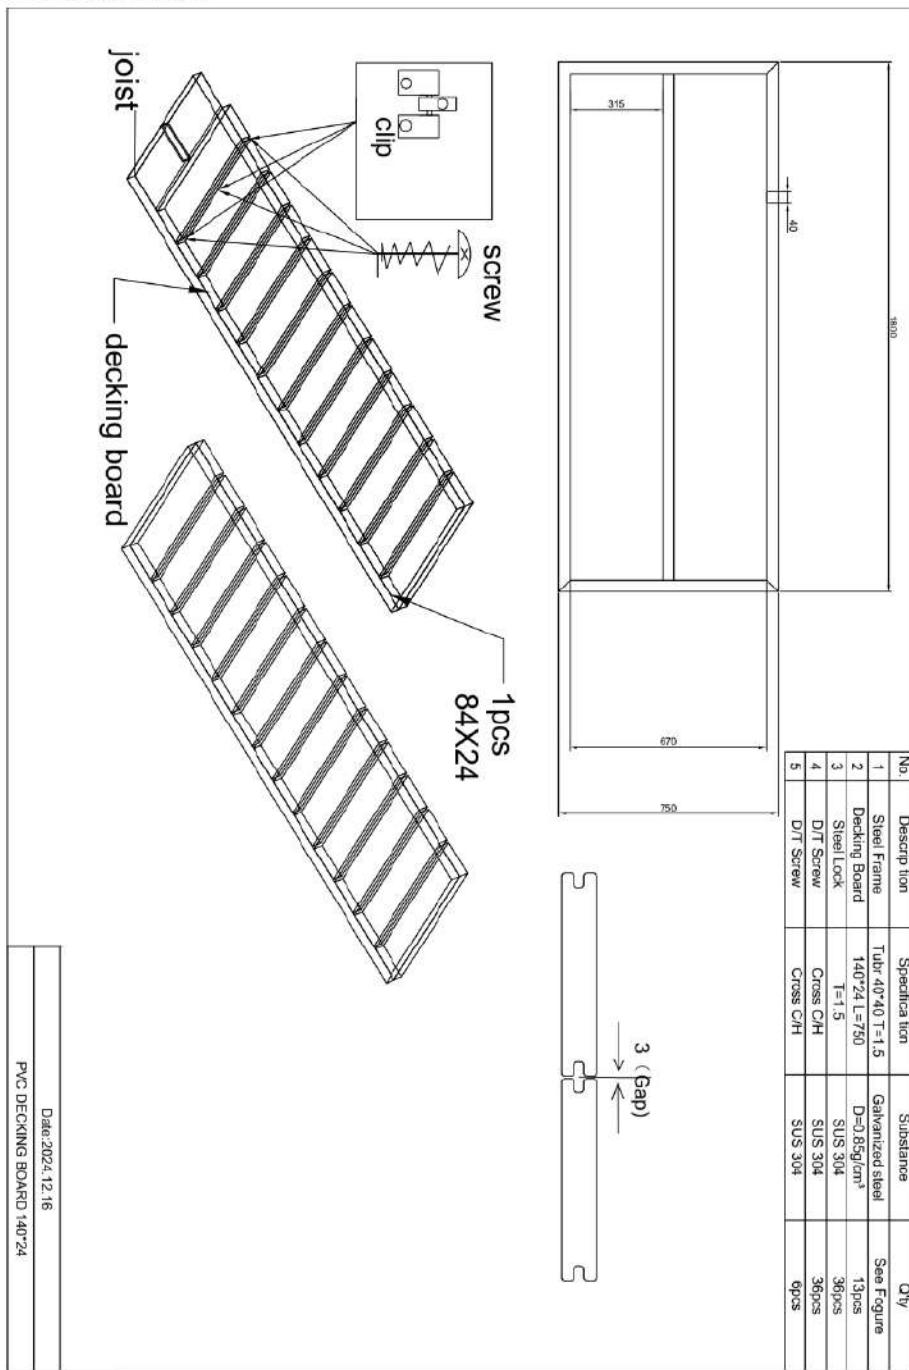
### SECTION 6 TEST SAMPLE DRAWINGS

Dimension drawing of the test specimen

NO	ITEM NAME	SPECIFICATION
1	Decking board	Premium PVC Decking Density: 0.85 g/cm <sup>3</sup> ; Nominal Size: 140 mm wide × 24 mm thick, 750 mm long
2	Decking screws	Type: Self-tapping screws; Material: Stainless steel 304; Size: Ø3.75x15.7mm
3	Joist	Material: Galvanized Steel tube; Section Size: 40 mm × 40 mm × 1.5 mm thick; Overall size: 1800 mm wide by 750 mm deep
Fixing		One piece 84 mm wide and 12 pieces 140 mm wide decking boards were placed side by side on steel joist. The steel joist was constructed with three lengthwise steel tubes and two transverse steel tubes connected by fully welding per each end. Each decking board was locked with steel clips along board joints on the joists and secured by self-tapping screws. Additional three self-tapping screws were applied along the side edge of the outboard decking board.

The test assembly comprised a nominal 1800 mm wide × 750 mm deep × 450 mm high deck that was set within an 1800 mm wide × 250 mm deep recess formed within a nominal 3000 mm × 3000 mm wall system which met the minimum requirements as specified by AS 3959 for the specified exposure level. The joists of the deck were supported by steel bars from the underside to get a

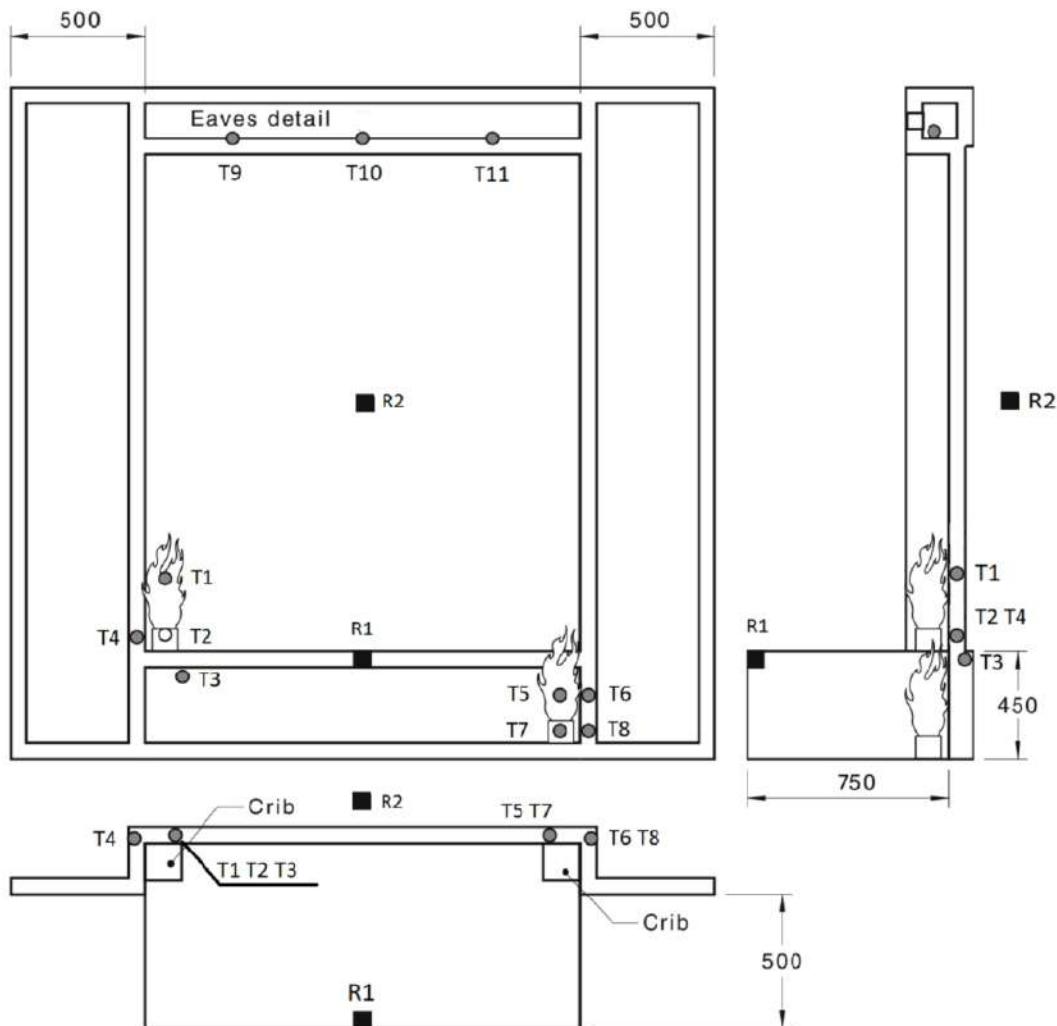
### SECTION 8 TEST MEASUREMENT DATA

- = Position for internal maximum temperature of the wall and eave
- = Location for radiant heat flux

Position for measurement of internal maximum temperature and radiant heat flux were presented in the drawing of Section 8.

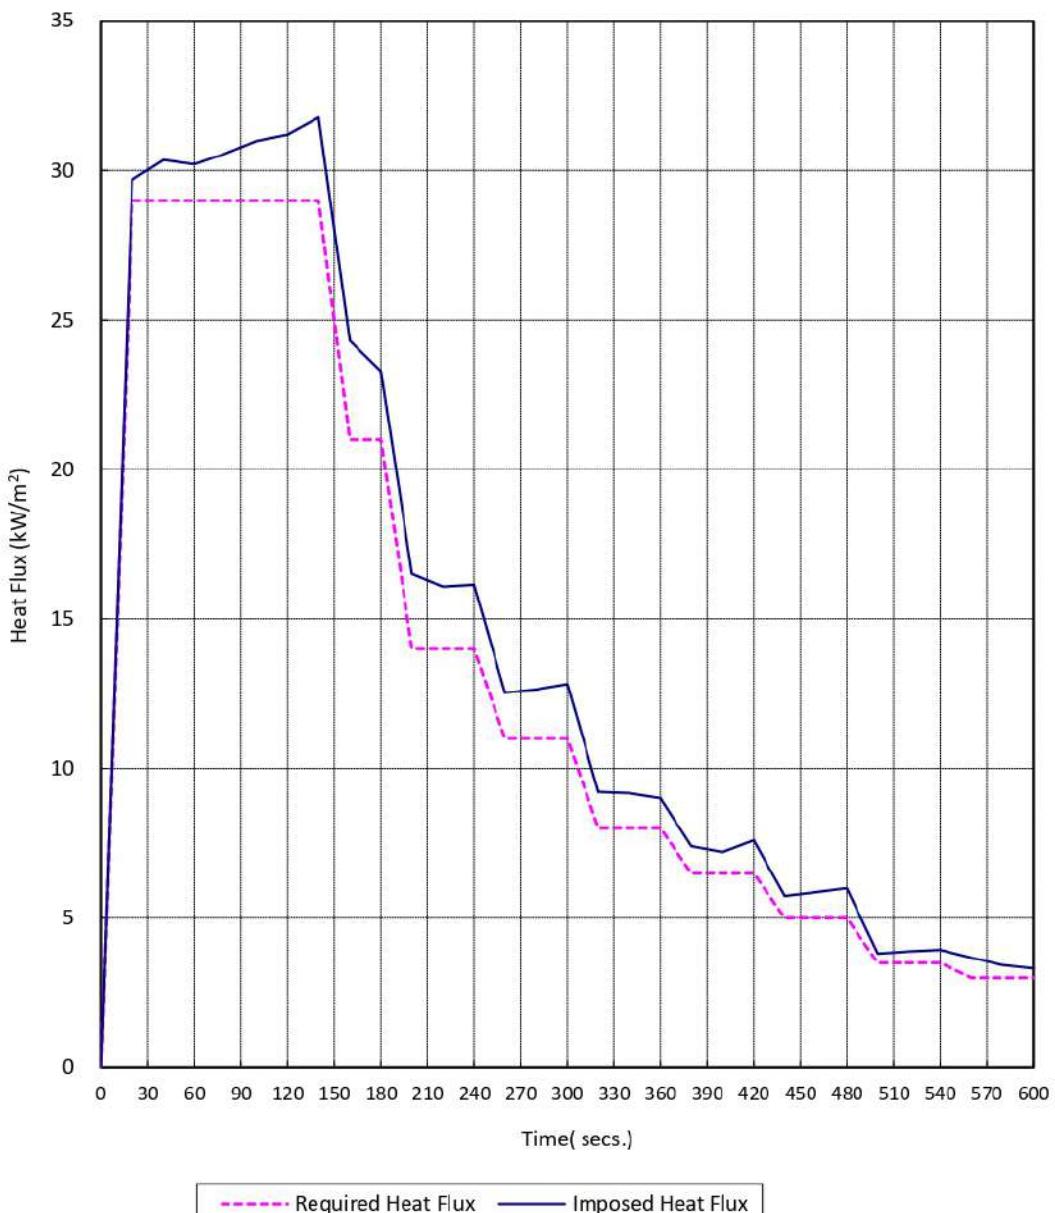
### Graph for imposed heat flux and heat flux profiles specified in the standard

Time/ Secs	Specified Heat Flux/ kW/m <sup>2</sup>	Incident Heat Flux / kW/m <sup>2</sup>
0	0	0.0
20	29	29.7
40	29	30.4
60	29	30.2
80	29	30.6
100	29	31.0
120	29	31.2
140	29	31.8
160	21	24.3
180	21	23.3
200	14	16.5
220	14	16.1
240	14	16.1
260	11	12.5
280	11	12.7
300	11	12.8
320	8	9.2
340	8	9.2
360	8	9.0
380	6.5	7.4
400	6.5	7.2
420	6.5	7.6
440	5	5.7
460	5	5.9
480	5	6.0
500	3.5	3.8
520	3.5	3.9
540	3.5	3.9
560	3	3.7
580	3	3.4
600	3	3.3

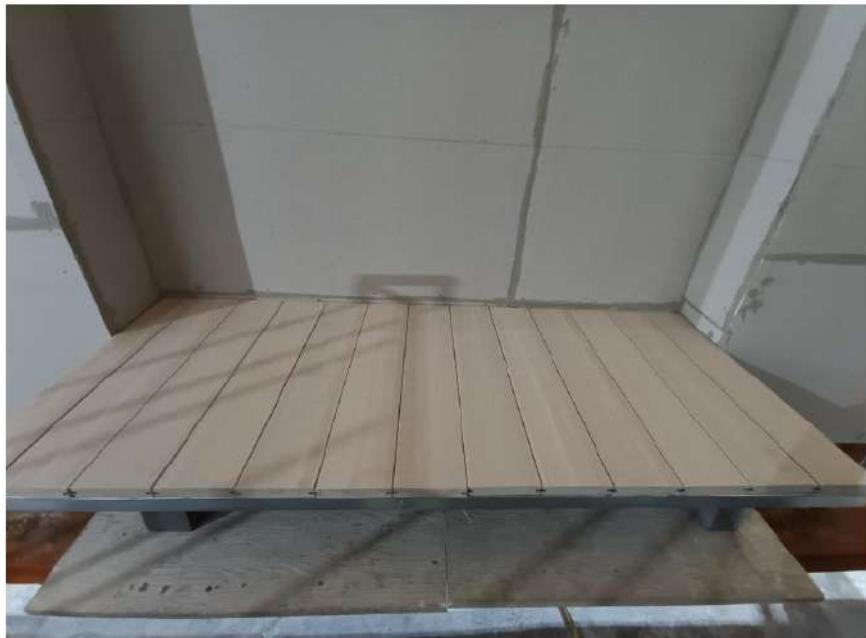
Fig. 1 Exposed Side Prior to the radiant heat test
